Manhole Inspection Summary

Manhole # S19GG_002MH

Insp Date: **6/14/07 9:30 AM**

Location Address: **1519 APPLETON-MONROE**

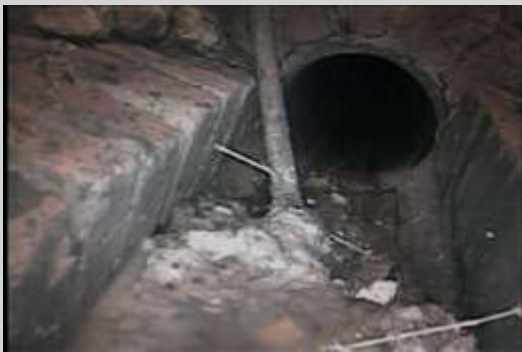
12 O'Clock Outflow

8 in. Circular Gravity Sewer
Pipe Out @ 12 O'Clock

Pipe Height: **7.2** (in.) Rod and Bar (Angled)
Pipe Material: **Clay** ☐ Pipe Lined
Invert Depth: **7.44** (ft.) Flow Characteristics: **Slow**
Deposits: ☒ None ☐ Mud ☐ Sludge ☐ **Debris** ☐ Grease
Silt Depth: (in.) Deposits Extent:
Infiltration: **None** Pipe Seal Cond: **Sound**
